Production Chemical Optimization Congress

Examining How to Cost Efficiently Deliver Chemicals For Paraffin And Corrosion Treatment On Rod Pumps And Success In Reducing Failure Rates

Presented by: Leslie Malone
Senior Staff Engineer
July 29-30, 2016 Houston, Texas

Murphy Oil-Eagle Ford Operations

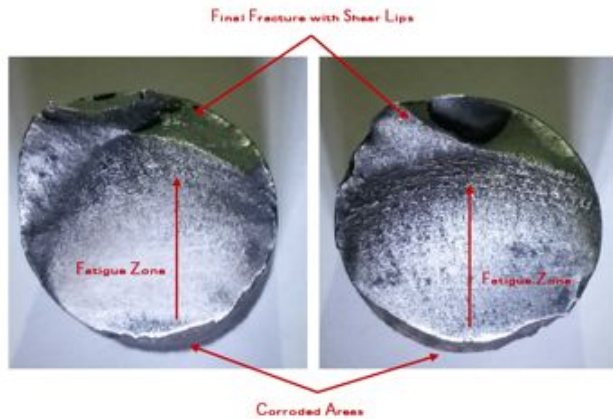
Figure 4. Fracture Surface

Failure analysis report documenting corrosion fatigue failure.

Failure was found on 31st 7/8" rod at 2,987'. Figure 4 shows the fracture surface after cleaning. The pattern is characteristic of a fatigue processes which started in the external surface in a severe corroded area (Figure 5). Then, fracture propagated by a fatigue mechanism, to finally crack as a consequence of the lack of section to withstand the load.

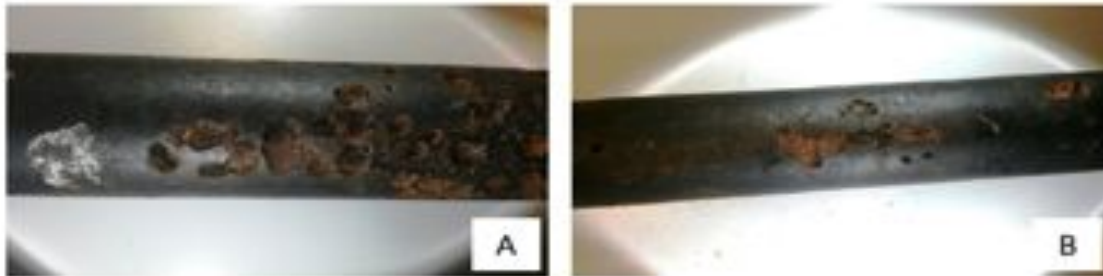
Figure 3. Body Corrosion

Samples exhibit severe corrosion with deep and sharp pits all over rod surface. (Figures 3).

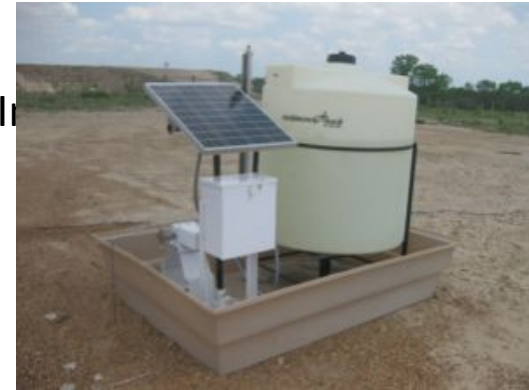
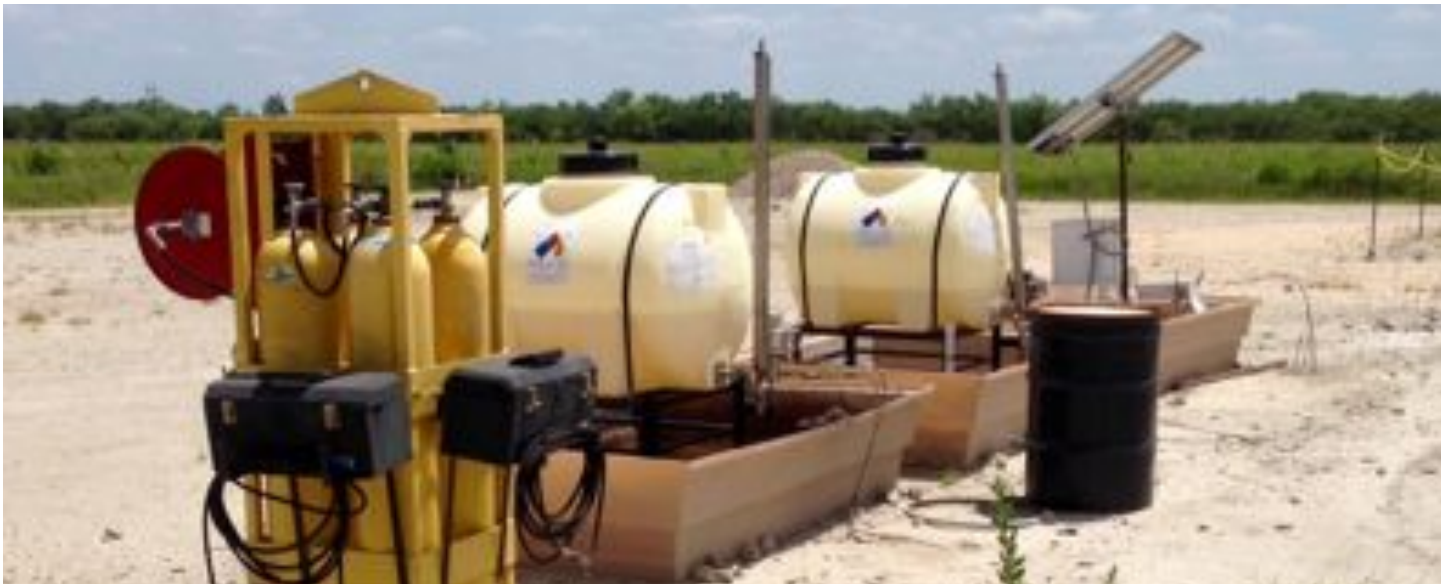
Chemical Pumps

- Fit for purpose
- Maintenance
- Injection Rate

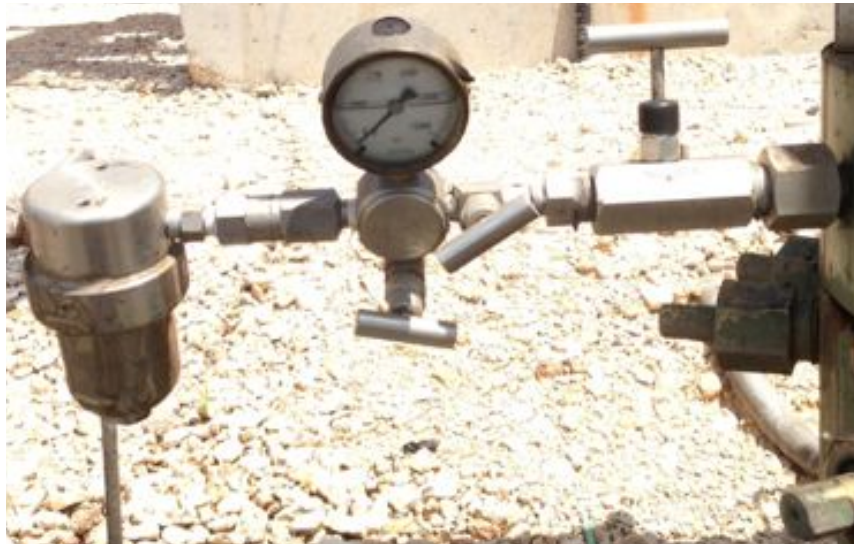
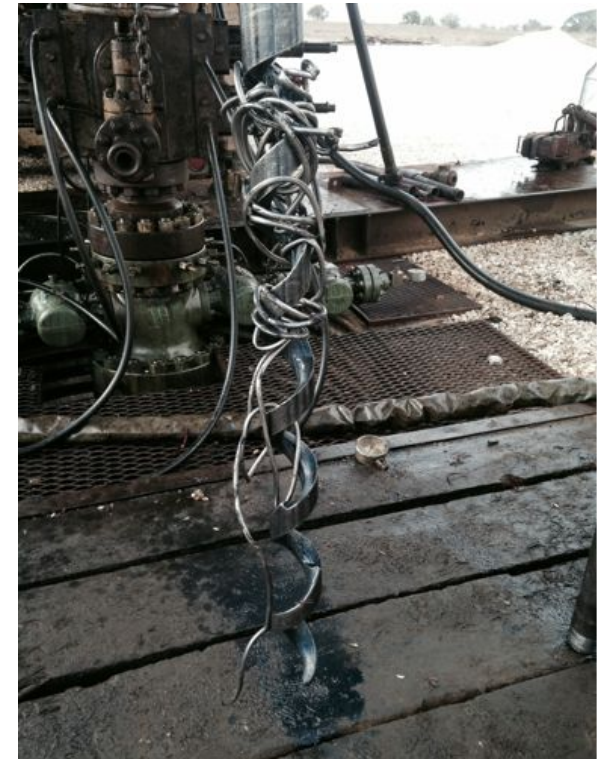
Cap Strings

- Installed at 5000 ‘
- Connected
- Plugged
- Failures

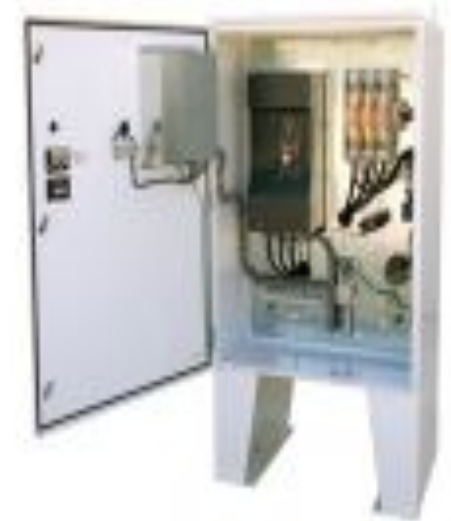
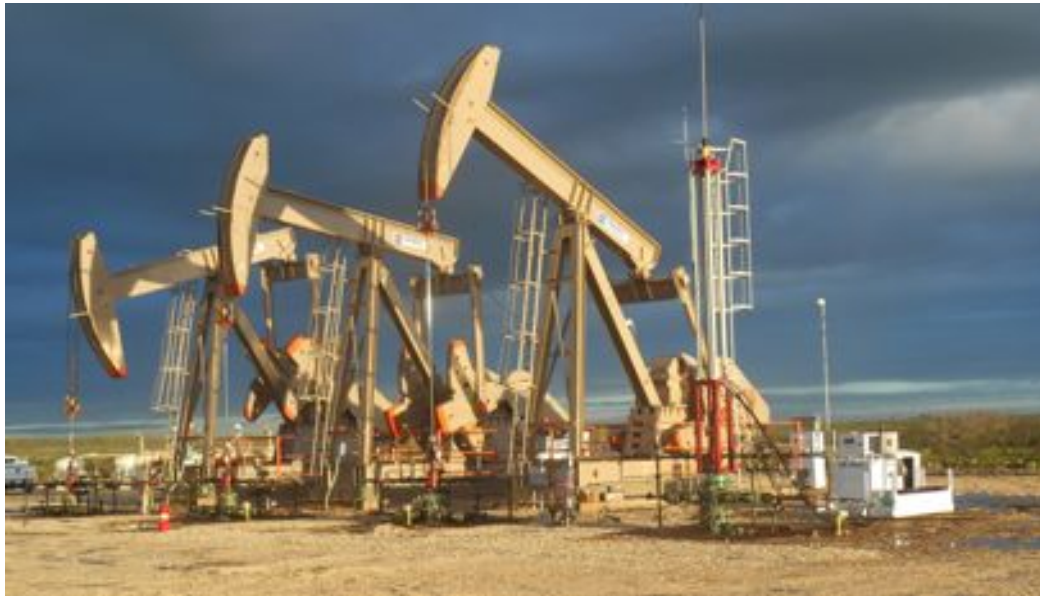
Automation of Chemical Pump with VSD

- ◆ VSD to automate injection rate
- ◆ Adjust rate based on production
- ◆ Shut off chemical automatically when well is down
